A View from the Bridge

for the Friends of the Union Chain Bridge

Restoration Progress Supplement – No 4 – January 2021

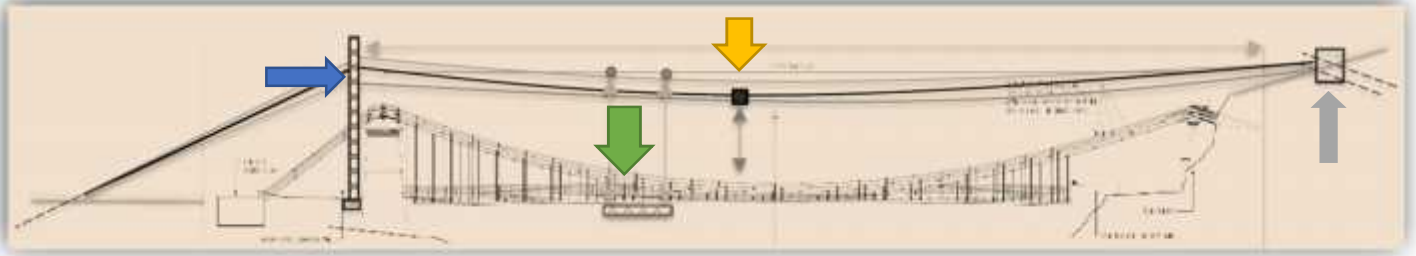
Sketch of the access system – Spencer Group/VIM

The drawing above is a more accurate representation of the current dismantling arrangements than that shown in our April 2019 Newsletter and on pages 38 and 39 of *Spanning the Centuries* when it was planned to dismantle the Bridge - and later to re-assemble it - from pontoons moored in the River Tweed underneath the superstructure. This drawing shows the Spencer Group solution, with the

“Blondin” aerial cableway (see details below) and associated installations. The **blue arrow** shows the lattice tower adjacent to the Scottish masonry tower, to accommodate the cableway. The **green arrow** shows the under-deck cradle which will allow workmen to access the Bridge decking from beneath, replacing the pontoon-mounted cherrypicker which was originally proposed. Other cradles suspended on to the two Bridge footpaths will enable the workforce to dismantle the Bridge components from deck level. The **yellow arrow** identifies the cable for the Woodliner self-propelled crane (*left*) described in Newsletter 3, while the **grey arrow** shows the location of the English-side temporary cradle anchor for the cableway and the Woodliner dock.

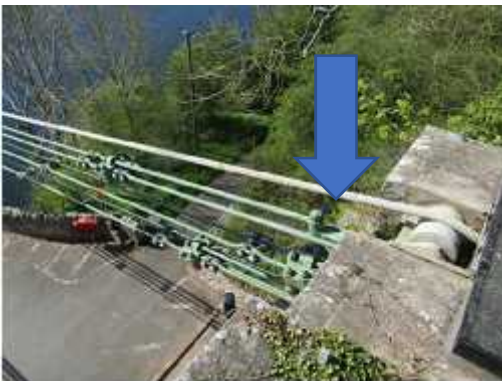
Phase 2 of the restoration began on January 18th with the removal of the 1903 steel cable wires (*left, arrowed*) and their hangers. You’ll recall that these were installed by the Tweed Bridges Trustees after they had received a report from their Surveyor, H Sneyd-Kinnersley, that the Bridge was becoming unsafe and incapable of supporting the loads to which it was subject. Recent surveys have shown that the rope serves no useful purpose and may actually have been damaging the Bridge by restricting its natural movement. It will not be replaced. We’ll be referring to the rope again in our March Newsletter.

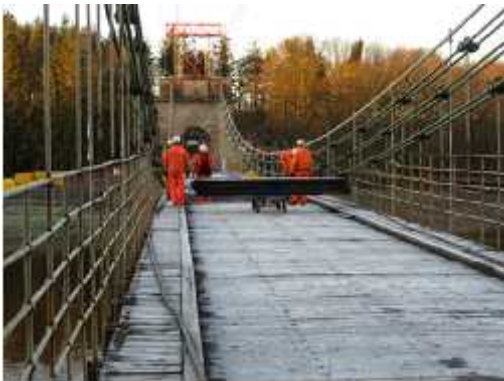
The timber deck elements are the first to be removed; the main transverse and longitudinal elements are about 5.5m long and are being taken off starting from the centre of the span and working outwards (*left*)

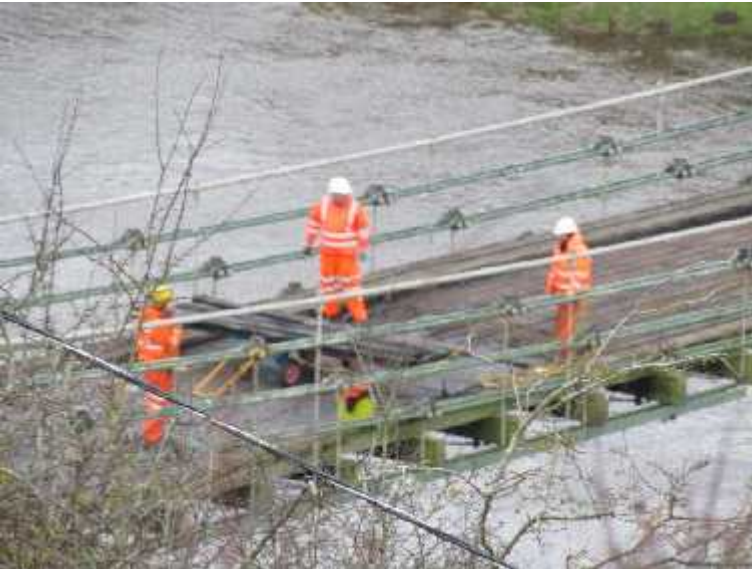
The removal of the Bridge decking is a long and painstaking job and a working day in the middle of the Bridge in mid-January requires considerable personal insulation.

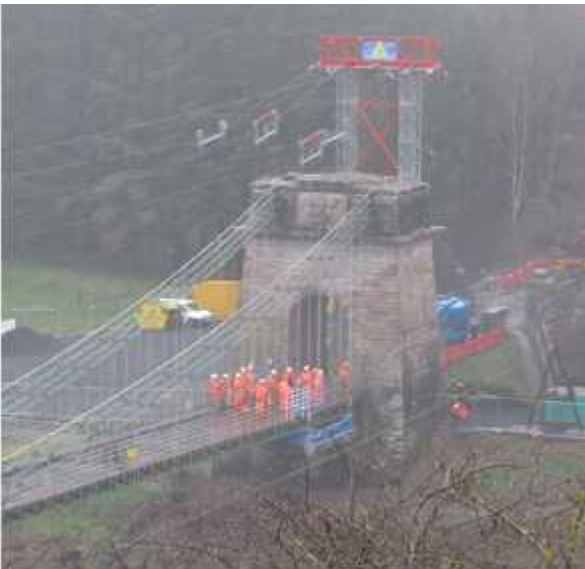
January 18th at 9am; an early morning staff briefing at the start of a week that would see the removal of all the wire rope hangers and the two wire ropes themselves, as well as the continuing removal of the decking materials and completion of the English tower access platform.

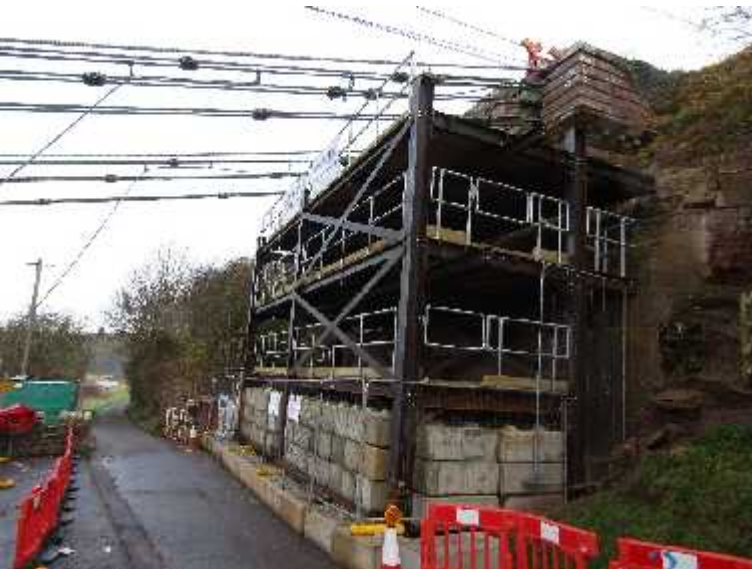
The English tower access platform; a substantial steel erection immediately in front of the English tower, to be used for several operations including the de-tensioning of the chains prior to disconnection; the reception of chains hauled across by a series of winches; to facilitate the boring of multiple-strand anchors into the rock; and the restoration and, where necessary, the replacement of the tower masonry. The Rose and Thistle crest (and that on the Scottish tower) will be removed from the tower for restoration. The Woodliner cable crane can just be seen in its dock above the tower.

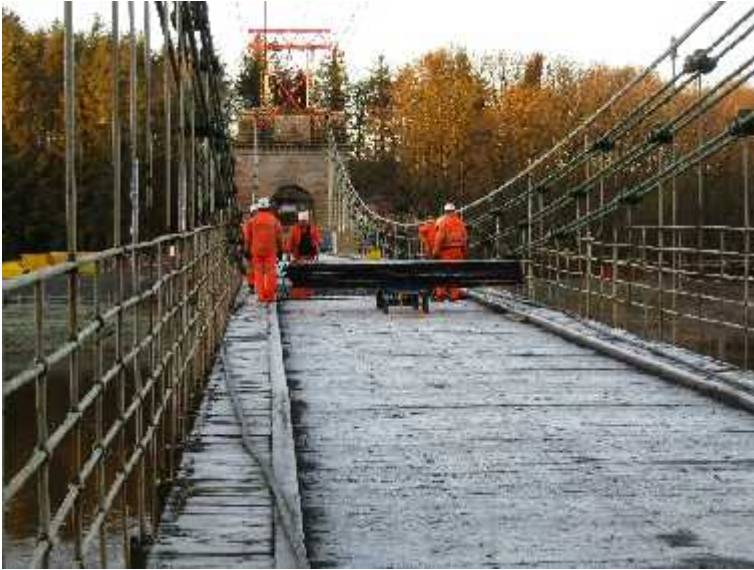
Removal of the decking material has continued daily since work resumed after the Christmas break.

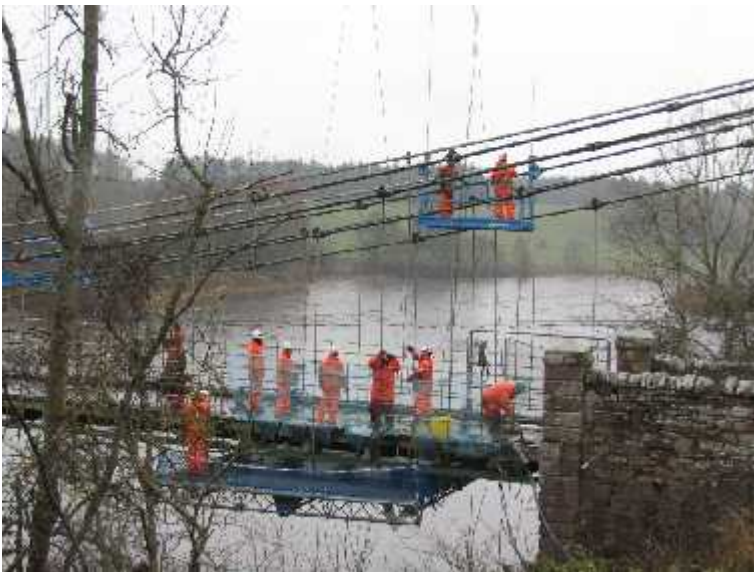
January 19th – Working from one of the personnel cradles at wire rope level and from the underslung platform at deck level, members of the Spencer workforce detach and remove the last of the wire rope hangers, at the English end of the Bridge, having worked their way across from the Scottish tower. Five days are allowed for completion of this work, but it is achieved in two days.

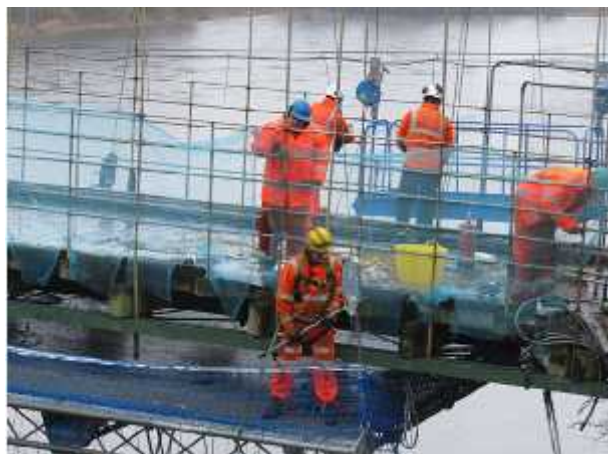
Another image of the cradle and platform; the man in the foreground is adjusting the working height of the platform with a ratchet spanner.

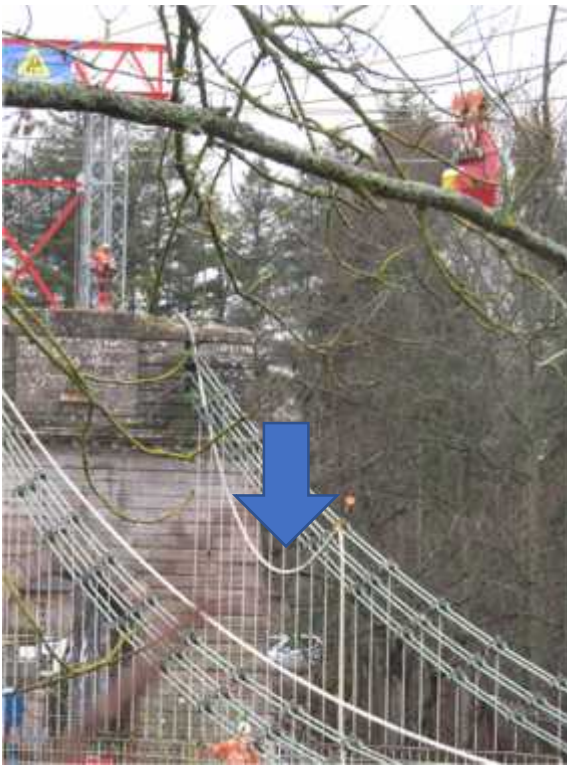
On January 20th the downstream wire rope (arrowed) is detached and lowered to the deck 117 years after its installation. It is thought that during that time it served no purpose except as a secondary means of deck support, an insurance measure, to take the strain of the Bridge if the primary support – the chains themselves – suffered catastrophic failure.

The Woodliner cable crane, which assisted in the process, is visible behind the tree branch.

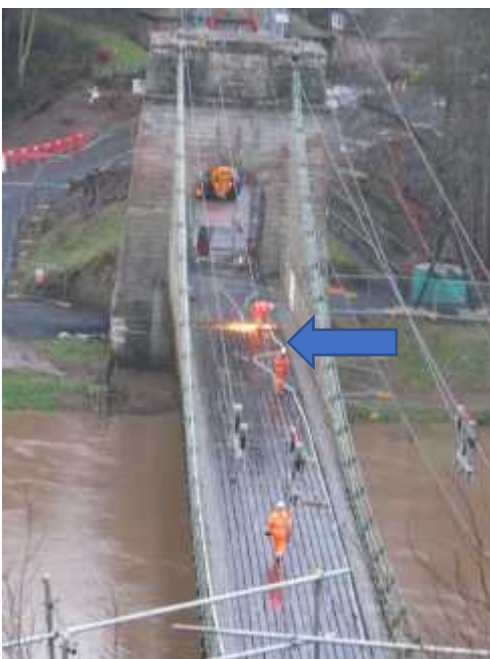
The rope, (arrowed) having been fully lowered to the deck, is now cut into manageable lengths for removal to the Project depot.
