# A View from the Bridge

**for the Friends of the Union Chain Bridge**

**Restoration Progress Supplement – No 5 – February 2021**

### **Phase 2 - Dismantling**

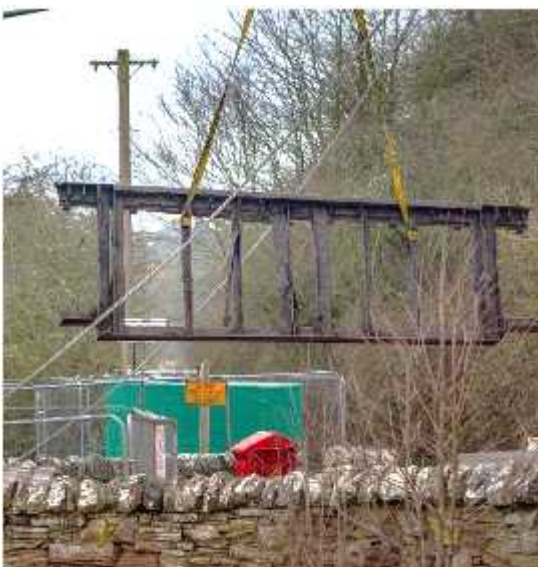
**27<sup>th</sup> January.** The articulated deck flap, 5ft in length at the English end of the Bridge decking, is removed to the depot. This flap was installed during the major works of 1974 to take up the deflection created when vehicles moved on or off the Bridge, resulting from the suspended platform ending at the riverbank abutment, while the chain cables continued for another 65ft to their point of contact with the abutment pier. In 1975 the road approach was lowered in relation to the hinged joint sections and now provided a level situation before loading. The deck flap will be replaced during reconstruction.

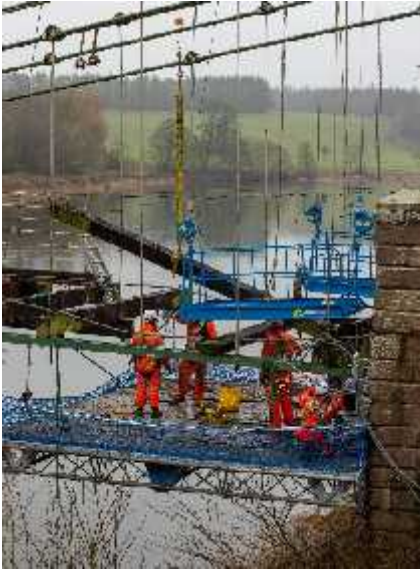
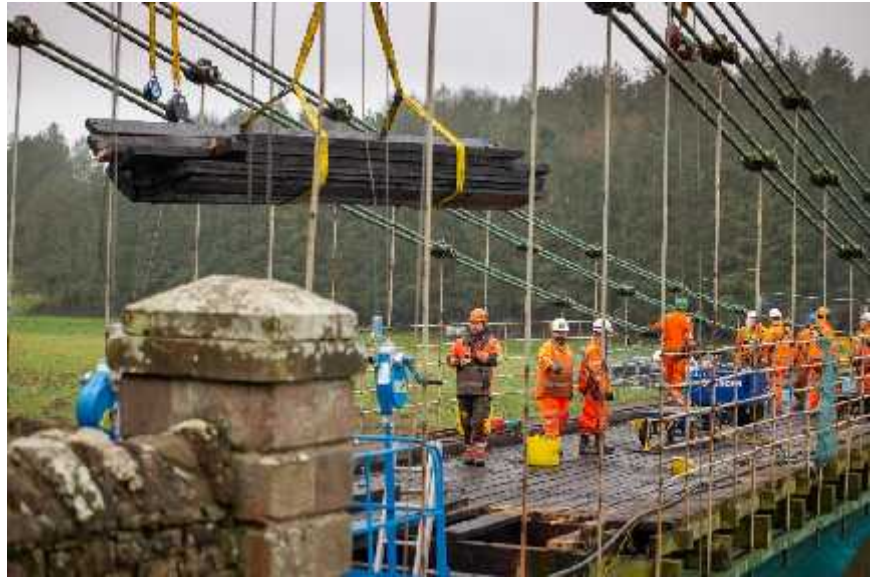
Above: *left and right* : **27<sup>th</sup> January** Deck timbers being removed to the English side by Woodliner cable crane.

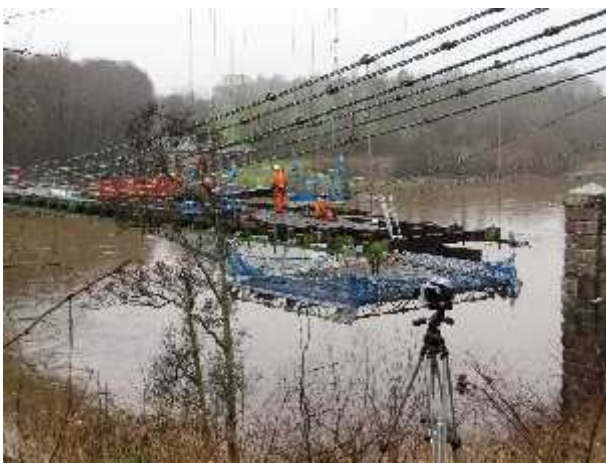
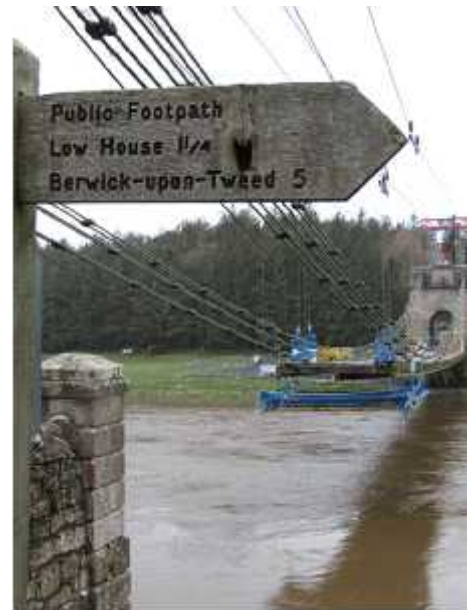
**29<sup>th</sup> Jan.** *Left:* Deck removal, with hangers and railings being dismantled using underslung platform and deck-level personnel cradles; and, *right, 7<sup>th</sup> Feb;* decking, hanger and railing removal almost 50% complete; the River Tweed is in spate

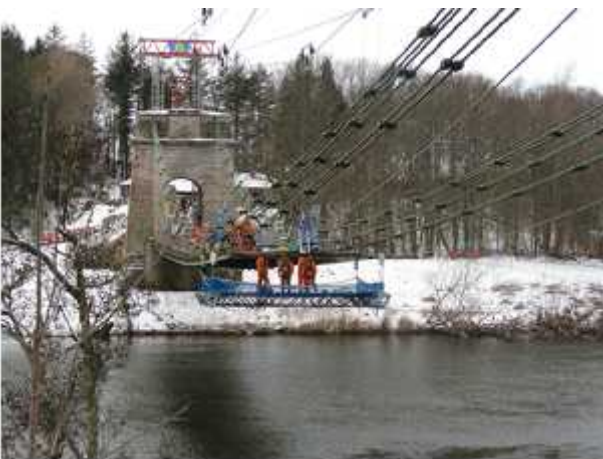
**12<sup>th</sup> Feb:** The snow was late in arriving at the Union Bridge but the need to clear the decking of snow accumulations delayed progress slightly at the beginning of the week commencing 8<sup>th</sup> February. But by Friday 12<sup>th</sup>, the half-way stage was reached. It is expected that the removal of the remaining decking, hangers and railings will be completed by early March leaving only the chains in place, to be removed during March.
